Electromigration Failure in Au and Joule Heating Induced Oxidation in Cu Conductors - Part 3

Task Manager: Rosa Leon

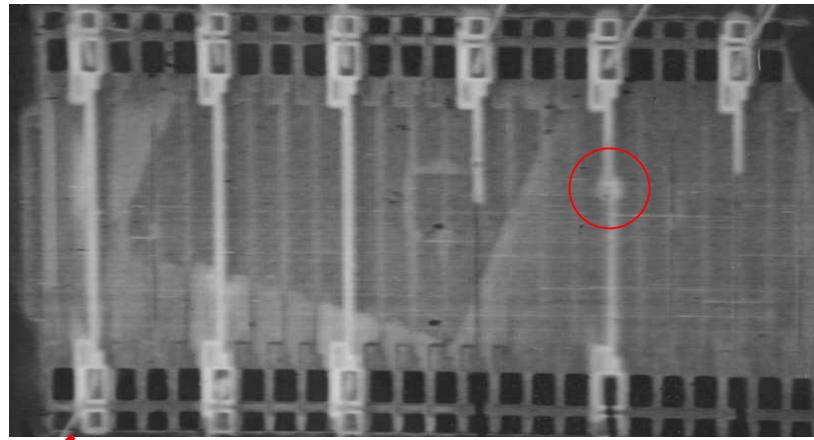
Here current continuity is still obtained, however, the leakage current across the polymer (sandwiched between Au and permalloy) is very large.

**R1 through R6 at 15x, 20 kV,
secondary electron mode**

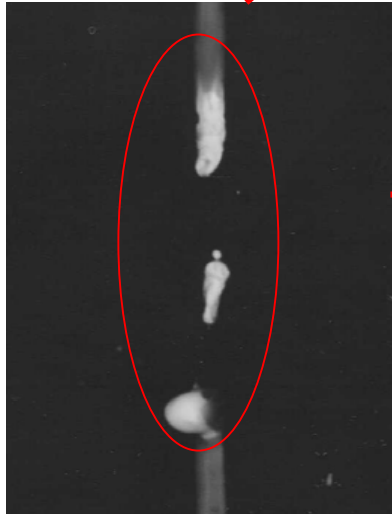
**R2 void at 400x, 20 kV,
backscattering mode**

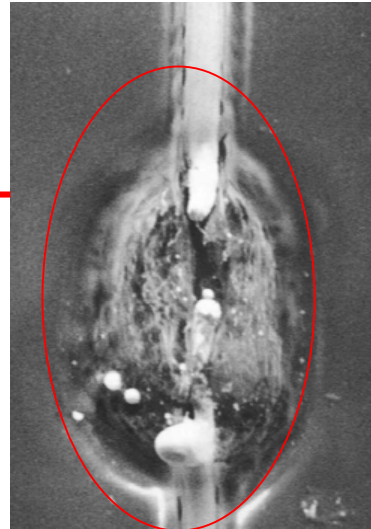
**R2 void at 400x, 20 kV,
secondary electron mode**

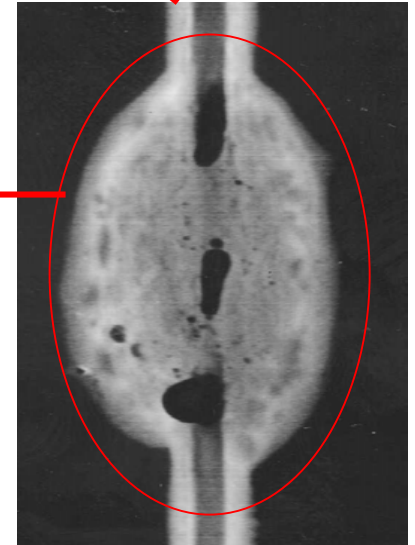
**R2 void at 400x, 20
kV, EBIC mode**

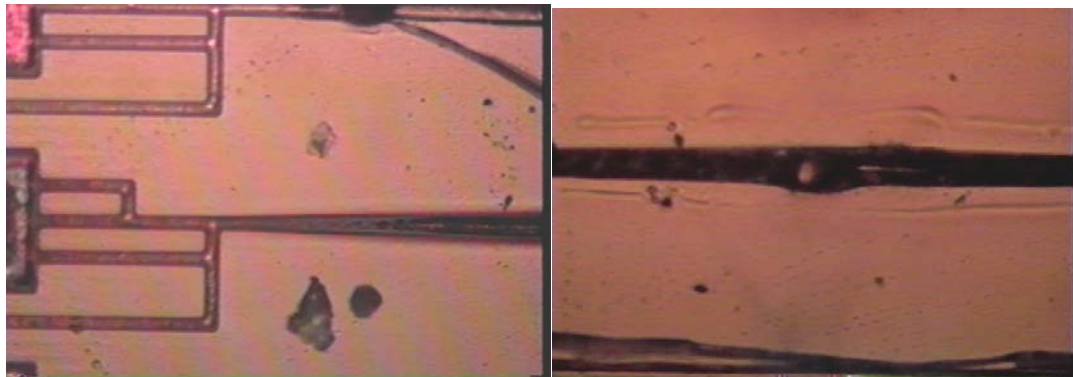
Using two probes at 60°C, our experiments show that Cu conductors failed in less than 7 hours at the following current densities: 2.13×10^6 , 2.07×10^6 , 2.03×10^6 , 1.9×10^6 and 1.85×10^6 Amp/cm². Joule heating occurred for all these values of current density. This can be clearly observed in the middle of the line, which deteriorated the polymer and exposed the lines to atmosphere. Since the Cu lines were exposed, they turned rapidly dark due to fast oxidation of Cu in air.

Joule heating and Oxidation
of Cu at 2.1×10^6 A/cm²

Central portion of the line.

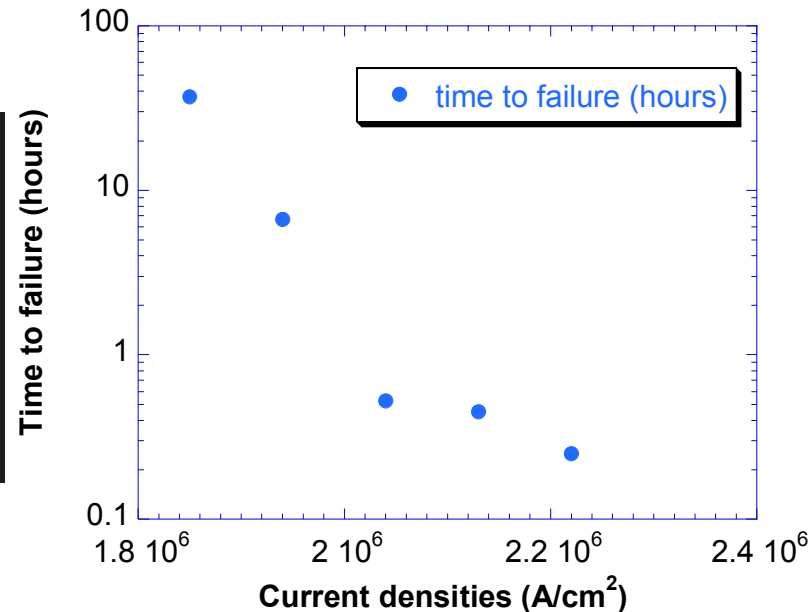
Current density vs. Time to failure of Cu test
structures measured at 60C and in air.

- At current densities $> 1.8 \times 10^5 \text{ A/cm}^2$ recovery is observed in Au interconnects. After a first increase in line resistance, the value of the resistance drops, showing an apparent “recovery”.
- Measurements of lifetimes at different current densities in air and at 60°C show that failure of unprotected Cu lines are mainly due to oxidation failure.

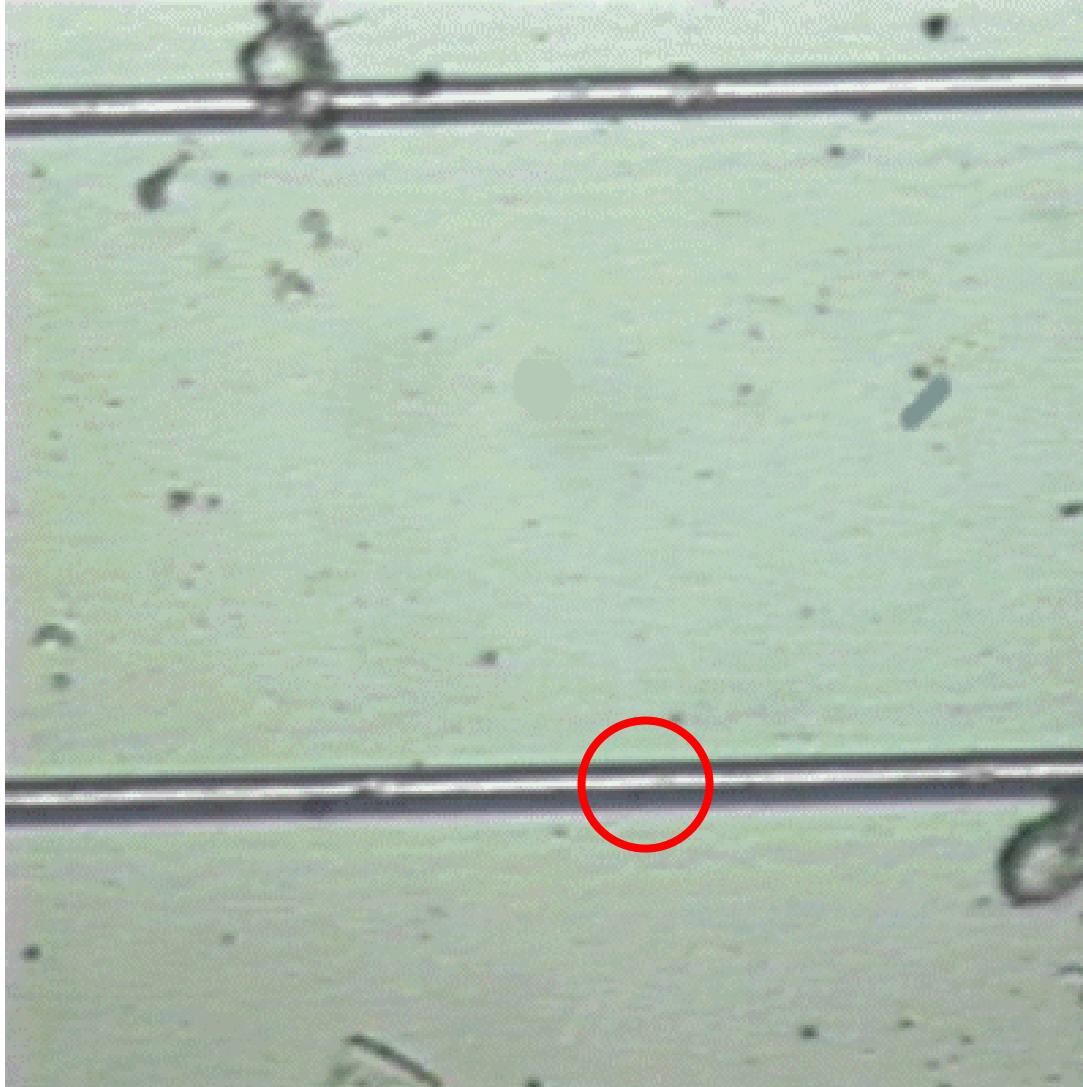
Film sequence showing rapid oxidation of Copper Interconnect under a current density of 14.8×10^4 mA/cm²
